PG&E Vegetation Management Initiatives in Response to the Drought Emergency

Quick Summary of PG&E's Electric VM Program

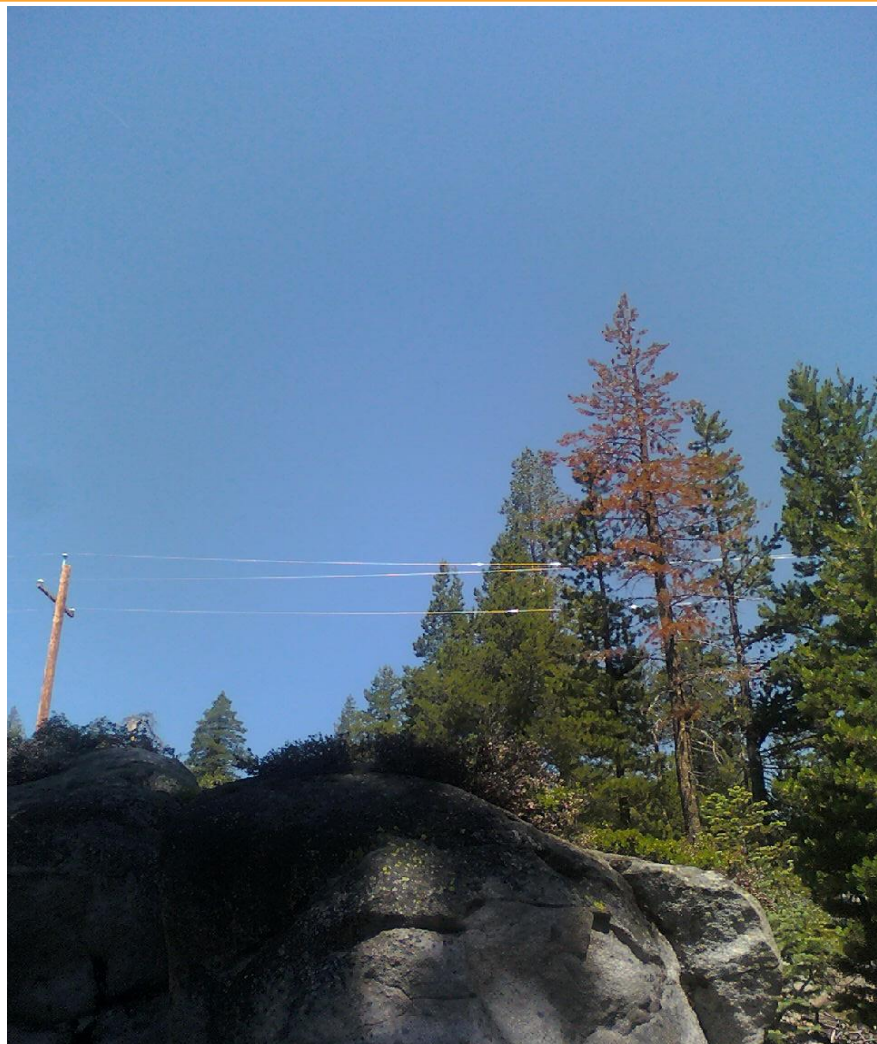
Hwy 4 near Alpine July 21, 2014

Hazardous Tree Examples

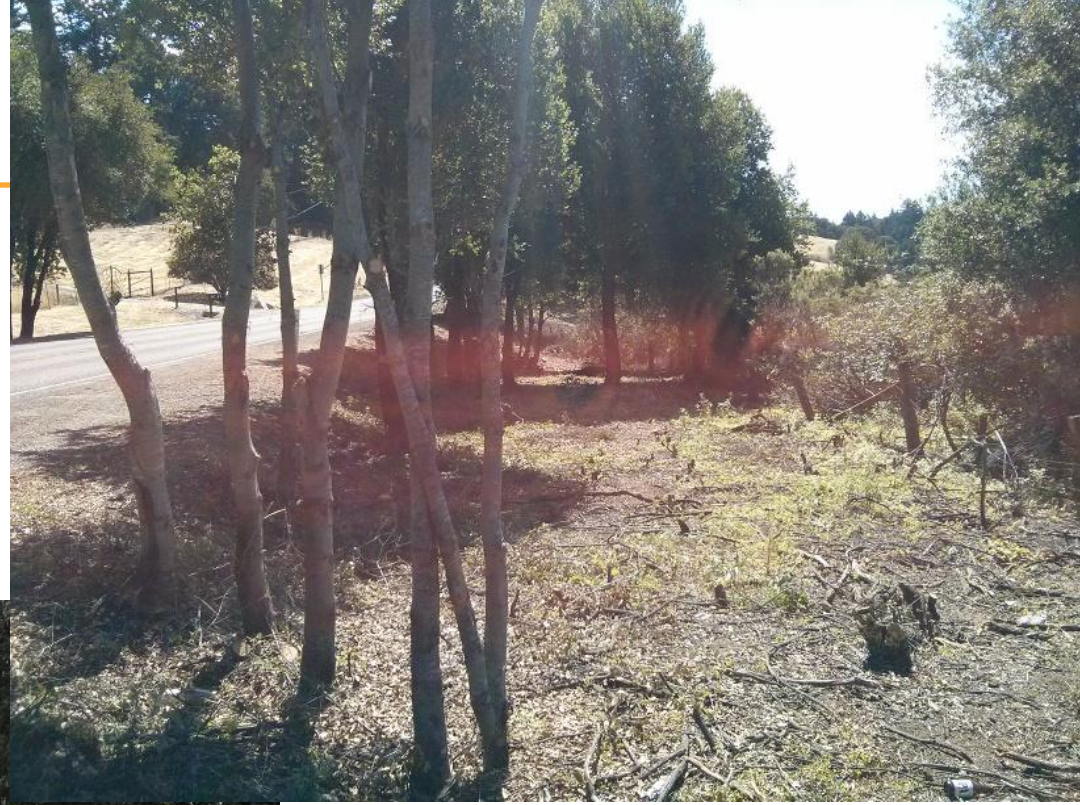
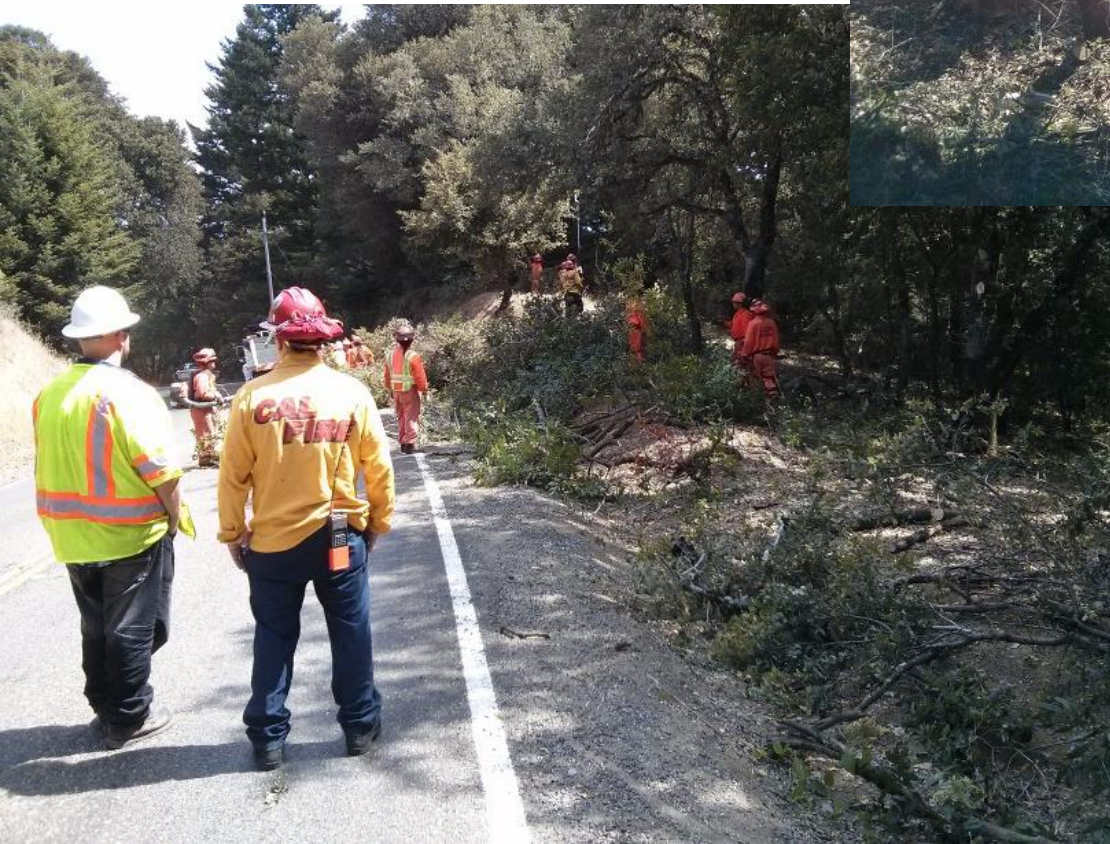
Drought Response - Fuel Reduction

Partnership between San Mateo FSC, Cal-Fire, Caltrans and PG&E

Combination of fuel break and shaded fuel break along HWY 35.
